**Flood Control Project Maintenance
Levee Inspections**

2019 Channel Summary Report

Fairfield Suisun Sewer District

Levee Inspection Report By Mile - Channel 2019

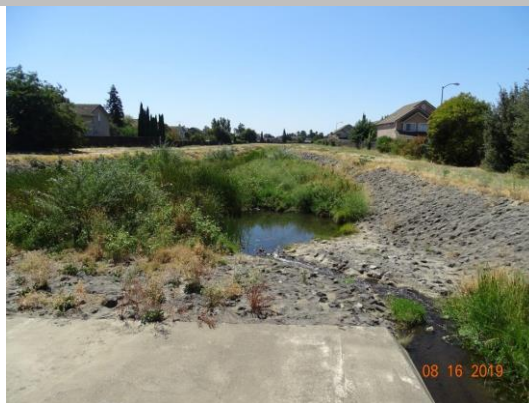
Photo 1 of 1 : CH_2019_NA0035_15_6_20190819_00102.jpg

View of the channel looking downstream. Summer 2019.

Inspector Comments: Vegetation should be cleared from the channel.

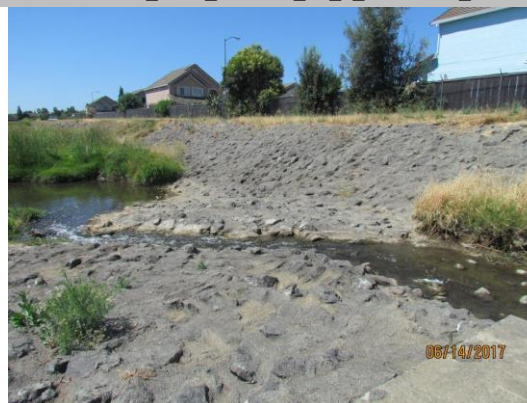
Photo 1 of 1 : CH_2019_NA0035_15_9_20190801_00012.jpg

Rating **	A	Issue No.	9	GPS Lat/Long
Issue Type +	Ma	Location *		38.279937 °
Category	Rivers, Channels & Designated Flood			-122.018354 °
Item	Revetments			
DWR ID	DWR_NA0035_15_c_2012_9			
Action/Comments				
Inspector Comments: Existing riprap protection is properly maintained and is undamaged. Riprap clearly visible.

View of revetment on the right bank looking downstream towards Pilot Channel. Summer 2017.

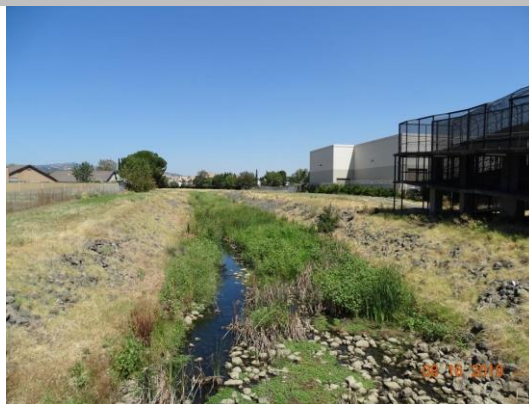
Photo 1 of 1 : CH_2019_NA0035_15_11_20190819_00101.jpg

Rating **	A	Issue No.	11	GPS Lat/Long
Issue Type +	Ma	Location *		38.272625 °
Category	Rivers, Channels & Designated Flood			-122.015993 °
Item	Vegetation & Obstructions			
DWR ID	DWR_NA0035_15_c_2012_11			
Action/Comments				
Inspector Comments: Minimal, scattered obstructions or vegetation. The flow is not impeded.

View of the channel looking upstream. Summer 2019.

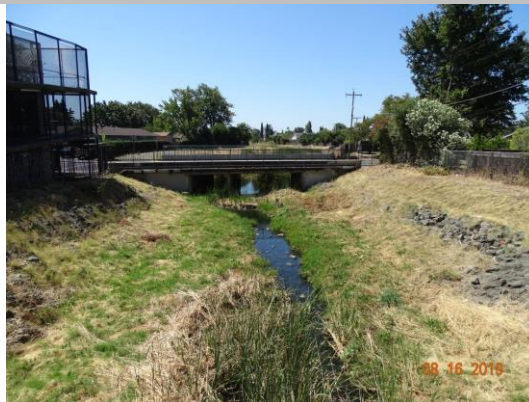
Photo 1 of 1 : CH_2019_NA0035_15_16_20190819_00100.jpg

Rating **	A	Issue No.	16	GPS Lat/Long
Issue Type +	Ma	Location *		38.272633 °
Category	Rivers, Channels & Designated Flood			-122.016110 °
Item	Vegetation & Obstructions			
DWR ID	DWR_NA0035_15_c_2012_16			
Action/Comments				
Inspector Comments: Minimal, scattered obstructions or vegetation. The flow is not impeded.

View of the channel looking downstream. Summer 2019.

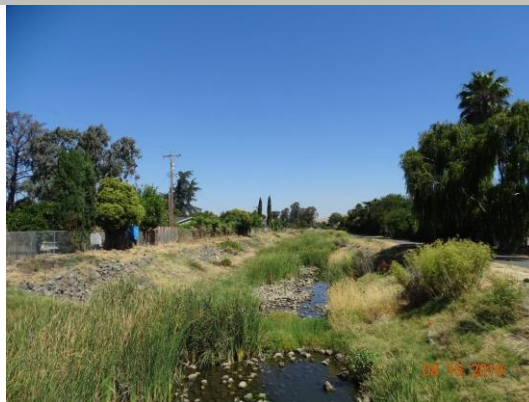
Photo 1 of 1 : CH_2019_NA0035_15_21_20190819_00099.jpg

Inspector Comments: Minimal, scattered obstructions or vegetation. The flow is not impeded.

View of the channel looking upstream. Summer 2019.

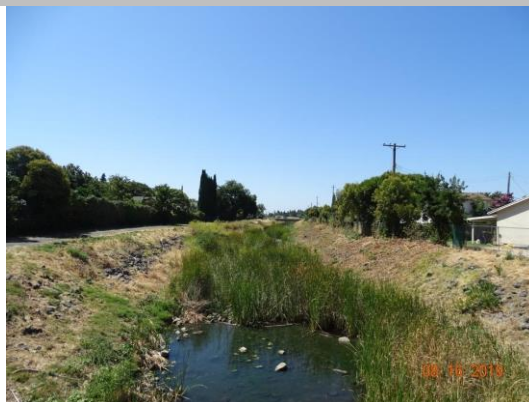
Photo 1 of 1 : CH_2019_NA0035_15_26_20190819_00098.jpg

Inspector Comments: Minimal, scattered obstructions or vegetation. The flow is not impeded.

View of the channel looking downstream. Summer 2019.

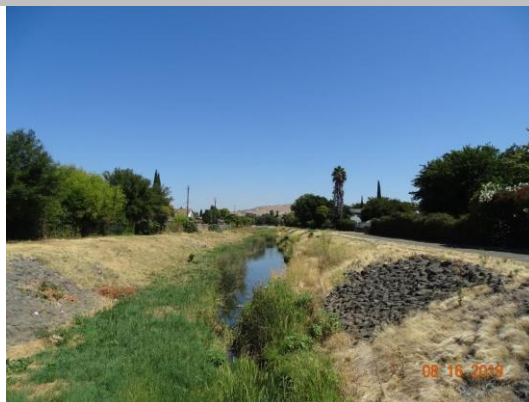
Photo 1 of 1 : CH_2019_NA0035_15_31_20190819_00097.jpg

Rating **	A	Issue No.	31	GPS Lat/Long
Issue Type +	Ma	Location *		38.265401 °
Category	Rivers, Channels & Designated Flood			-122.018316 °
Item	Vegetation & Obstructions			
DWR ID	DWR_NA0035_15_c_2012_31			
Action/Comments				
Inspector Comments: Minimal, scattered obstructions or vegetation. The flow is not impeded.

View of the channel looking upstream. Summer 2019.

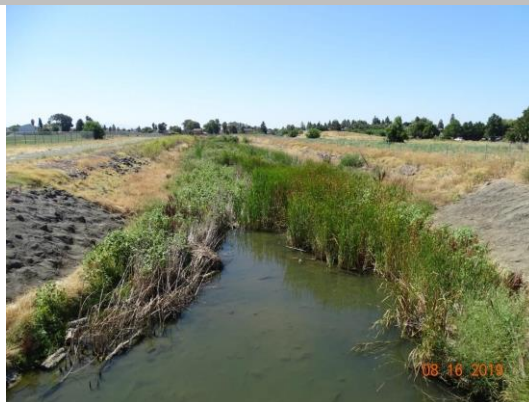
Photo 1 of 1 : CH_2019_NA0035_15_36_20190819_00096.jpg

Inspector Comments: Minimal, scattered obstructions or vegetation. The flow is not impeded.

View of the channel facing downstream. Summer 2019.

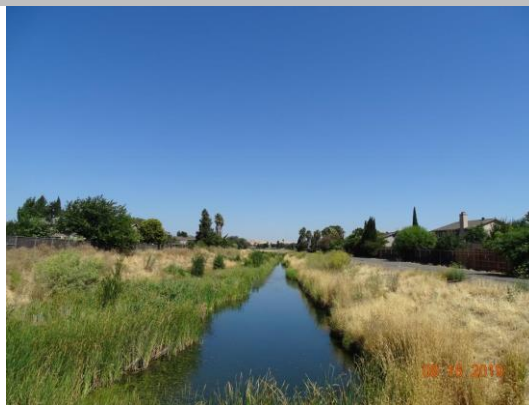
Photo 1 of 1 : CH_2019_NA0035_15_41_20190819_00095.jpg

Inspector Comments: Minimal, scattered obstructions or vegetation. The flow is not impeded.

View of the channel looking upstream. Summer 2019.

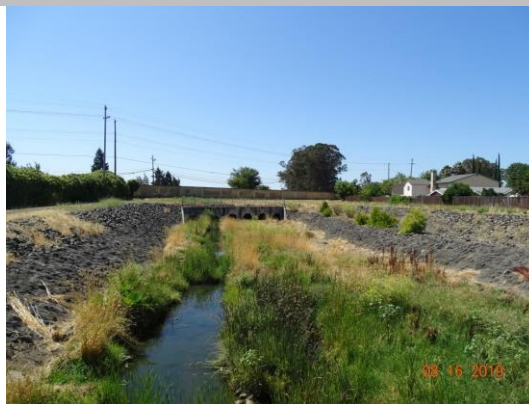
Photo 1 of 1 : CH_2019_NA0035_15_46_20190819_00094.jpg

Rating **	A	Issue No.	46	GPS Lat/Long
Issue Type +	Ma	Location *		38.259272 °
Category	Rivers, Channels & Designated Flood			-122.017533 °
Item	Vegetation & Obstructions			
DWR ID	DWR_NA0035_15_c_2012_46			
Action/Comments				
Inspector Comments: Minimal, scattered obstructions or vegetation. The flow is not impeded.

View of the channel looking downstream. Summer 2019.

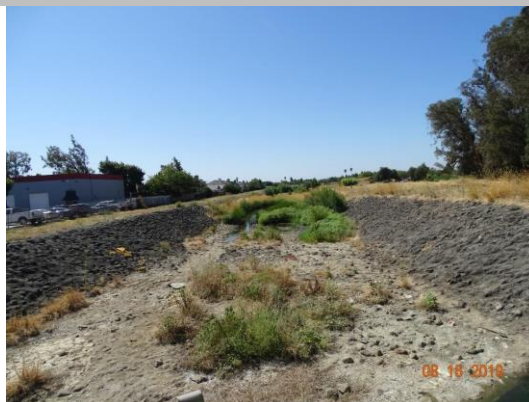
Photo 1 of 1 : CH_2019_NA0035_15_56_20190819_00093.jpg

Rating **	A	Issue No.	56	GPS Lat/Long
Issue Type +	Ma	Location *		38.257784 °
Category	Rivers, Channels & Designated Flood			-122.017733 °
Item	Vegetation & Obstructions			
DWR ID	DWR_NA0035_15_c_2012_56			
Action/Comments				
Inspector Comments: Minimal scattered obstruction or vegetation. The flow is not impeded.

View of the channel looking downstream. Summer 2019.

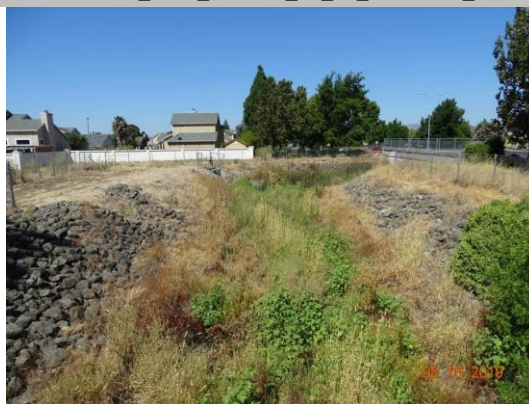
Photo 1 of 1 : CH_2019_NA0035_15_61_20190819_00092.jpg

Inspector Comments: Minimal scattered obstructions or vegetation. The flow is not impeded. This is an offshoot channel to Laurel Creek that is included within the Fairfield Streams O&M Manual.

View of the channel looking upstream. Summer 2019.

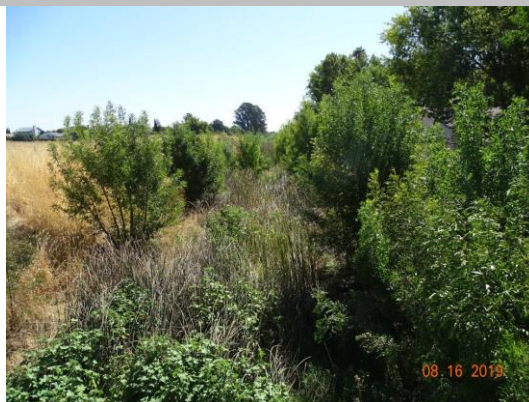
Photo 1 of 1 : CH_2019_NA0035_15_66_20190819_00091.jpg

Inspector Comments: Vegetation growth, bushes, and saplings block 25% of the channel. This is an offshoot channel to Laurel Creek that is included within the Fairfield Streams O&M Manual.

View of the channel looking downstream. Summer 2019.

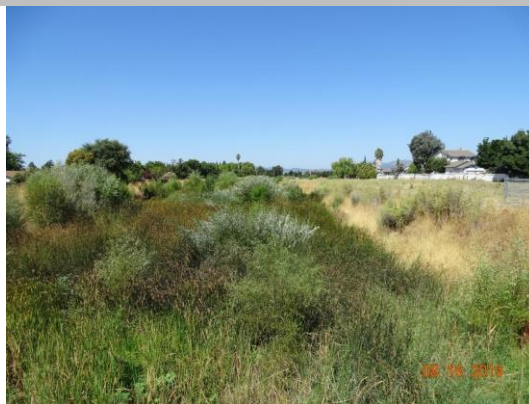
Photo 1 of 1 : CH_2019_NA0035_15_71_20190819_00090.jpg

Rating **	M	Issue No.	71	GPS Lat/Long
Issue Type +	Ma	Location *		38.253382 °
Category	Rivers, Channels & Designated Flood			-122.014862 °
Item	Vegetation & Obstructions			
DWR ID	DWR_NA0035_15_c_2012_71			
Action/Comments				
Inspector Comments: Vegetation growth, cat tails, bushes, or saplings block 25% of the channel.

View of the channel looking upstream. Summer 2019.

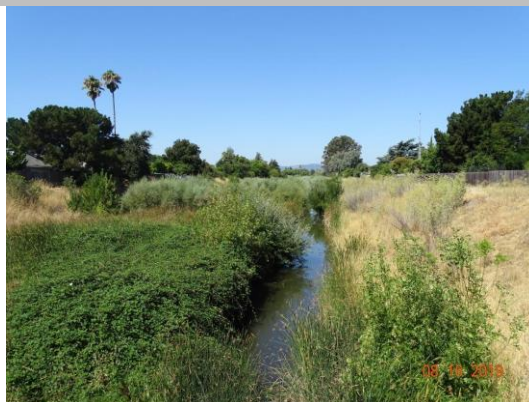
Photo 1 of 1 : CH_2019_NA0035_15_81_20190819_00088.jpg

Inspector Comments: Minimal, scattered obstructions or vegetation. The flow is not impeded.

View of the channel looking upstream. Summer 2019.

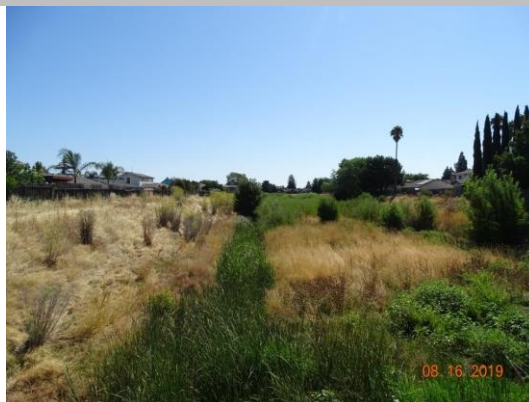
Photo 1 of 1 : CH_2019_NA0035_15_86_20190819_00087.jpg

Rating **	M	Issue No.	86	GPS Lat/Long
Issue Type +	Ma	Location *		38.253248 °
Category	Rivers, Channels & Designated Flood			-122.009732 °
Item	Vegetation & Obstructions			
DWR ID	DWR_NA0035_15_c_2012_86			
Action/Comments				
Inspector Comments: Vegetation growth (such as cat tails, bull rushes, bushes or saplings) or other obstructions block approximately 25% of the channel.

View of channel looking downstream. Summer 2019.

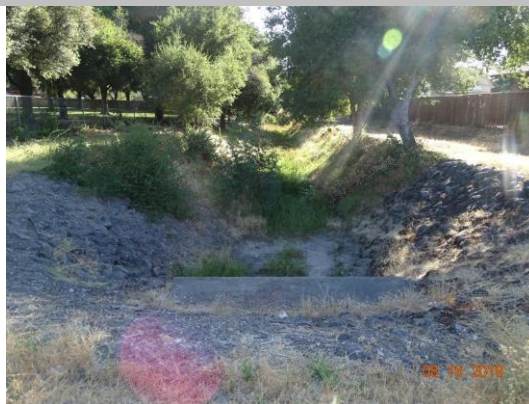
Photo 1 of 1 : CH_2019_NA0035_17_1_20190819_00072.jpg

Rating **	A	Issue No.	1	GPS Lat/Long
Issue Type +	Ma	Location *		38.256296 °
Category	Rivers, Channels & Designated Flood			-122.073705 °
Item	Vegetation & Obstructions			
DWR ID	DWR_NA0035_17_c_2012_1			
Action/Comments				
Inspector Comments: Minimal, scattered obstructions or vegetation. The flow is not impeded.

View of the channel looking upstream. Summer 2019.

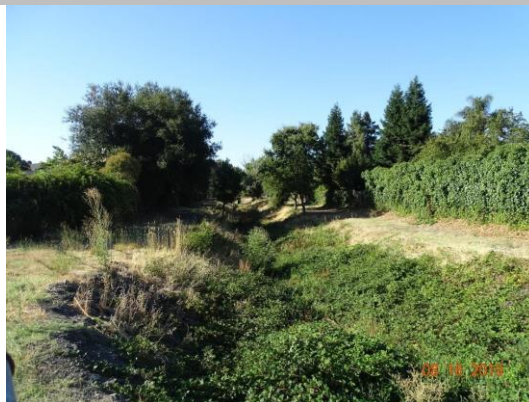
Photo 1 of 1 : CH_2019_NA0035_17_6_20190819_00073.jpg

View of the channel looking downstream. Summer 2019.

Inspector Comments: Blackberry bushes should be cleared out.

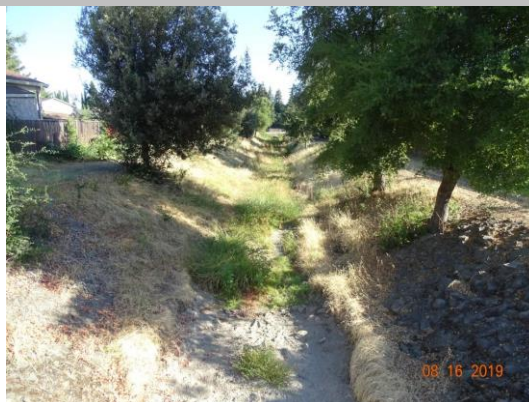
Photo 1 of 1 : CH_2019_NA0035_17_11_20190819_00074.jpg

Check Point / View				
Springfield Dr. / Up				
Rating **	A	Issue No.	11	GPS Lat/Long
Issue Type +	Ma	Location *		38.254594 °
Category	Rivers, Channels & Designated Flood			-122.073608 °
Item	Vegetation & Obstructions			
DWR ID	DWR_NA0035_17_c_2012_11			
Action/Comments				
Inspector Comments: Minimal, scattered obstructions or vegetation. The flow is not impeded.

View of the channel looking upstream. Summer 2019.

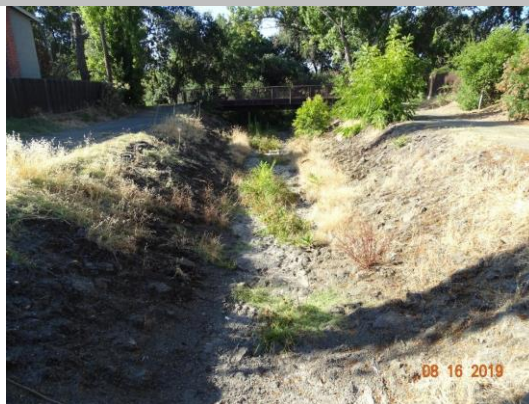
Photo 1 of 1 : CH_2019_NA0035_17_16_20190819_00075.jpg

Rating **	A	Issue No.	16	GPS Lat/Long
Issue Type +	Ma	Location *		38.254594 °
Category	Rivers, Channels & Designated Flood			-122.073608 °
Item	Vegetation & Obstructions			
DWR ID	DWR_NA0035_17_c_2012_16			
Action/Comments				
Inspector Comments: Minimal, scattered obstructions or vegetation. The flow is not impeded.

View of the channel looking downstream. Summer 2019.

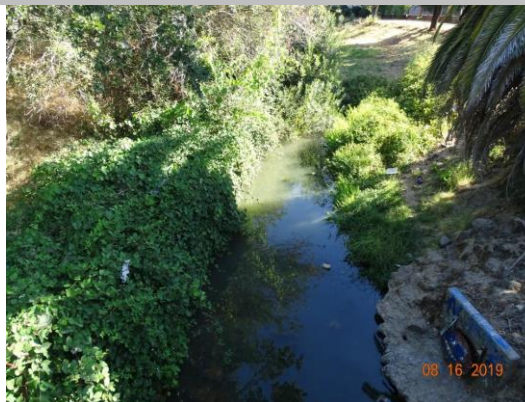
Photo 1 of 1 : CH_2019_NA0035_17_21_20190819_00076.jpg

Inspector Comments: Minimal, scattered obstructions or vegetation. The flow is not impeded.

View of the channel looking upstream. Summer 2019.

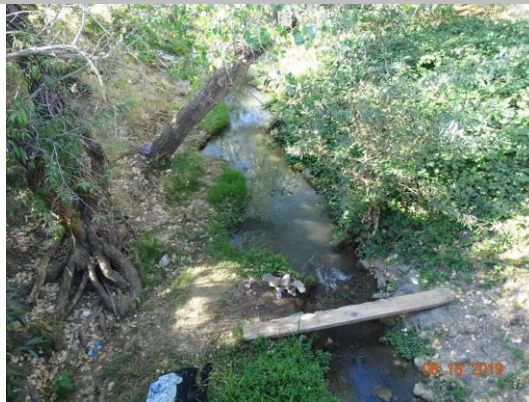
Photo 1 of 1 : CH_2019_NA0035_17_26_20190819_00078.jpg

Rating **	A	Issue No.	26	GPS Lat/Long
Issue Type +	Ma	Location *		38.249840 °
Category	Rivers, Channels & Designated Flood			-122.072644 °
Item	Vegetation & Obstructions			
DWR ID	DWR_NA0035_17_c_2012_26			
Action/Comments				
Inspector Comments: Minimal, scattered obstructions or vegetation. The flow is not impeded.

View of the channel looking downstream. Summer 2019.

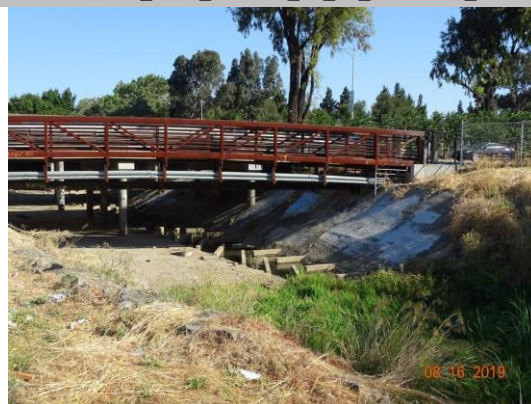
Photo 1 of 1 : CH_2019_NA0035_17_31_20190819_00079.jpg

Inspector Comments: Minimal, scattered obstructions or vegetation. The flow is not impeded.

View of the channel looking upstream. Summer 2019.

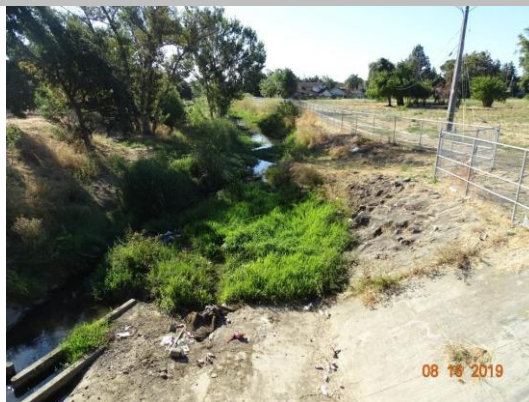
Photo 1 of 1 : CH_2019_NA0035_17_36_20190819_00080.jpg

Check Point / View				
Auto Mall Parkway / Down				
Rating **	A	Issue No.	36	GPS Lat/Long
Issue Type +	Ma	Location *		38.247722 °
Category	Rivers, Channels & Designated Flood			-122.072105 °
Item	Vegetation & Obstructions			
DWR ID	DWR_NA0035_17_c_2012_36			
Action/Comments				
Inspector Comments: Minimal, scattered obstructions or vegetation. The flow is not impeded.

View of the channel looking downstream. Summer 2019.

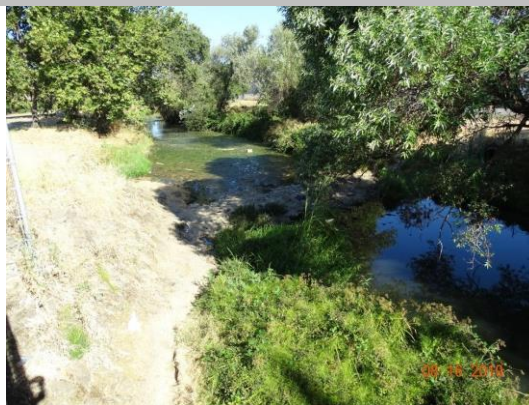
Photo 1 of 1 : CH_2019_NA0035_17_41_20190819_00082.jpg

Inspector Comments: Minimal, scattered obstructions or vegetation. The flow is not impeded.

View of the channel looking upstream. Summer 2019.

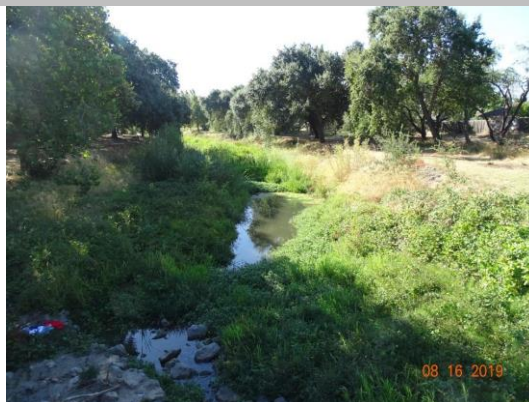
Photo 1 of 1 : CH_2019_NA0035_17_46_20190819_00083.jpg

Check Point / View				
Woolner Avenue / Down				
Rating **	A	Issue No.	46	GPS Lat/Long
Issue Type +	Ma	Location *		38.245298 °
Category	Rivers, Channels & Designated Flood			-122.068536 °
Item	Vegetation & Obstructions			
DWR ID	DWR_NA0035_17_c_2012_46			
Action/Comments				
Inspector Comments: Minimal, scattered obstructions or vegetation. The flow is not impeded.

View of the channel looking downstream. Summer 2019.

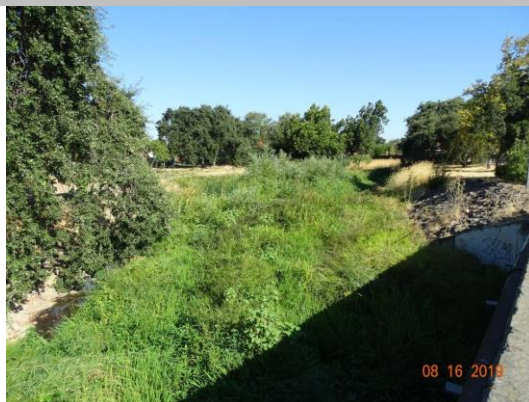
Photo 1 of 1 : CH_2019_NA0035_17_51_20190819_00084.jpg

Inspector Comments: Significant vegetation growth within the channel that approxiamtely blocks 25% of capacity.

View of the channel looking upstream. Summer 2019.

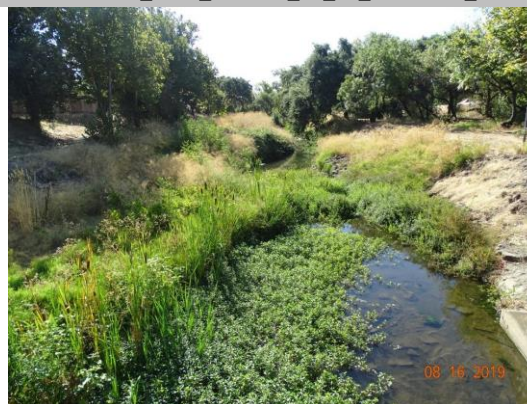
Photo 1 of 1 : CH_2019_NA0035_17_56_20190819_00085.jpg

Inspector Comments: Minimal, scattered obstructions or vegetation. The flow is not impeded.

View of the channel looking downstream. Summer 2019.

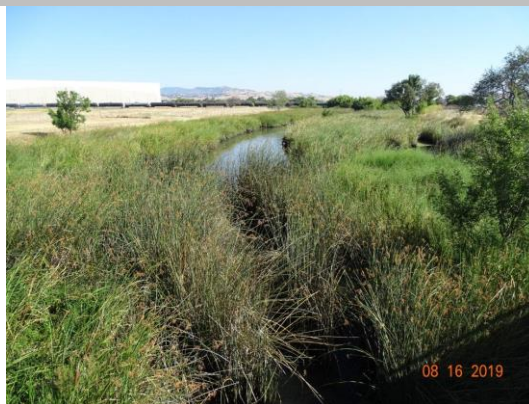
Rating **	A	Issue No.	66	GPS Lat/Long
Issue Type +	Ma	Location *		38.240590 °
Category	Rivers, Channels & Designated Flood			-122.062413 °
Item	Vegetation & Obstructions			
DWR ID	DWR_NA0035_17_c_2012_66			
Action/Comments				
Inspector Comments: Minimal, scattered obstructions or vegetation. The flow is not impeded.

View of the channel looking downstream from the railroad bridge.
Summer 2019.

View of the channel looking downstream from Highway 12. Summer 2017.

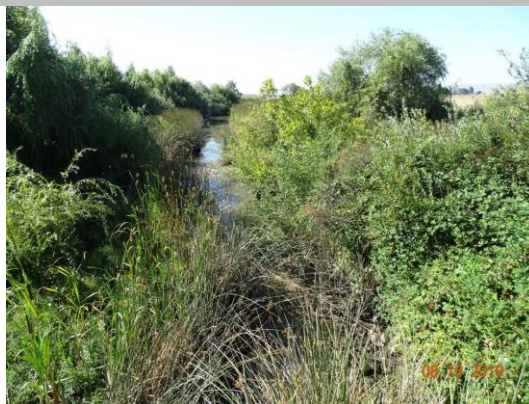
Photo 1 of 1 : CH_2019_NA0035_17_71_20190819_00089.jpg

Inspector Comments: Some vegetation present, but it does not appear to impede the flow.

View of the channel looking upstream. Summer 2019.

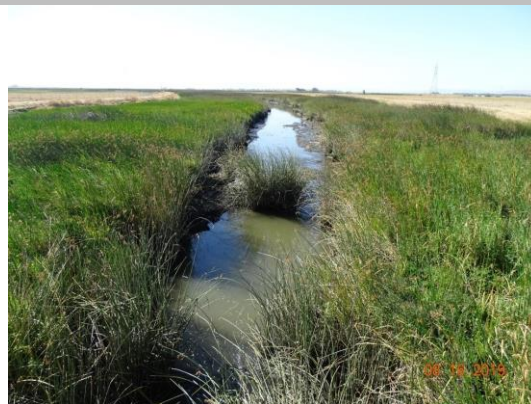
Photo 1 of 1 : CH_2019_NA0035_17_76_20190819_00088.jpg

Inspector Comments: Minimal, scattered obstructions or vegetation. The flow is not impeded.

View of the channel looking downstream. Summer 2019.

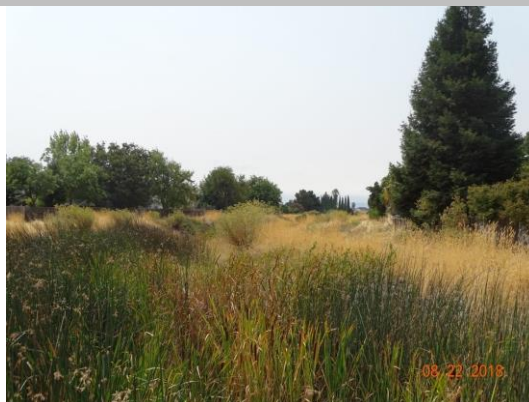
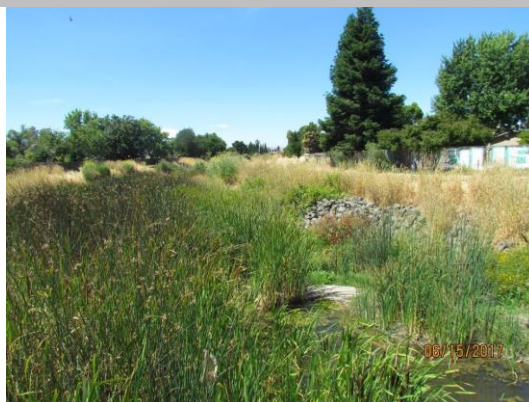
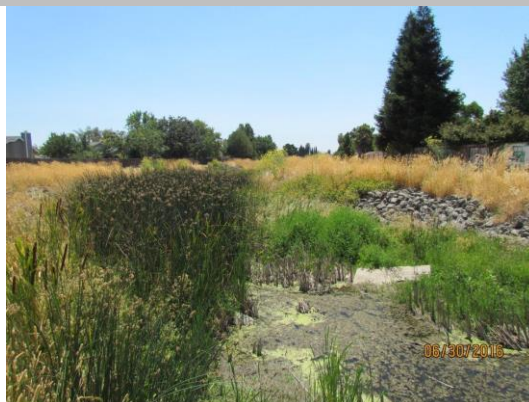
Inspector Comments: Vegetation blocks approximately 25% of the capacity. Unable to get photo due to fence blocking access.

View of the channel looking downstream. Summer 2018.

View of the channel looking downstream. Summer 2017.

View of the creek looking downstream at the end of Bella Vista Ave.
Summer 2016.

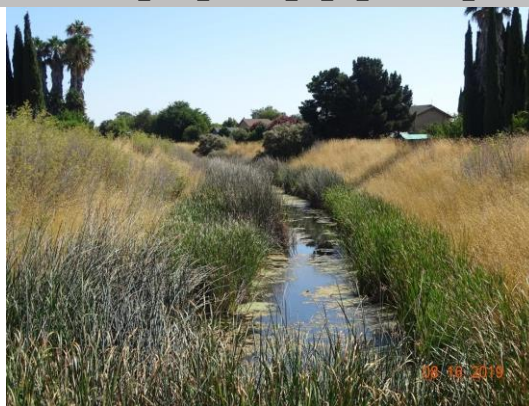
Photo 1 of 1 : CH_2019_NA0035_14_11_20190819_00040.jpg

Inspector Comments: Minimal vegetation in the channel. Does not reduce capacity.

View of the channel looking upstream. Summer 2019.

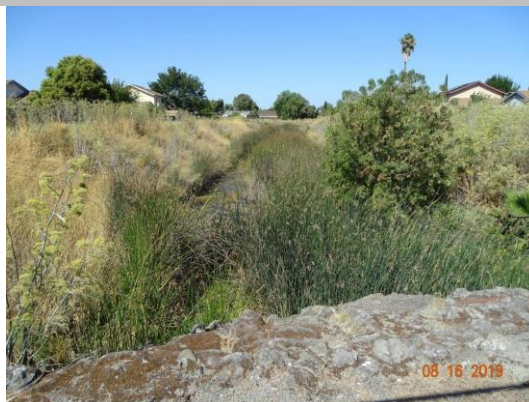
Photo 1 of 1 : CH_2019_NA0035_14_16_20190819_00039.jpg

View of the channel looking downstream. Summer 2019.

Inspector Comments: Cattails/bull rush need to be sprayed or removed at street crossing. Try to maintain 50 ft. to 100 ft. clearance.

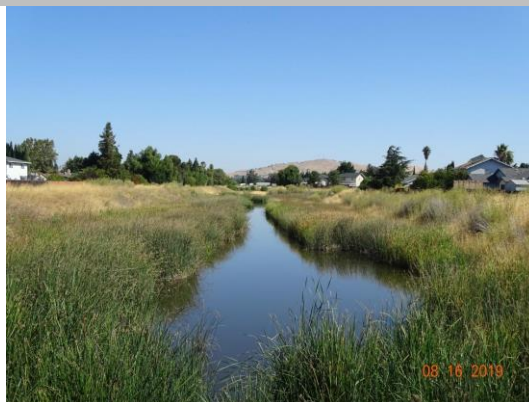
Photo 1 of 1 : CH_2019_NA0035_14_21_20190819_00038.jpg

Rating **	A	Issue No.	21	GPS Lat/Long
Issue Type +	Ma	Location *		38.248542 °
Category	Rivers, Channels & Designated Flood			-122.006378 °
Item	Vegetation & Obstructions			
DWR ID	DWR_NA0035_14_c_2012_21			
Action/Comments				
Inspector Comments: Minimal scattered obstruction or vegetation. The flow is not impeded.

View of the channel looking upstream. Summer 2019.

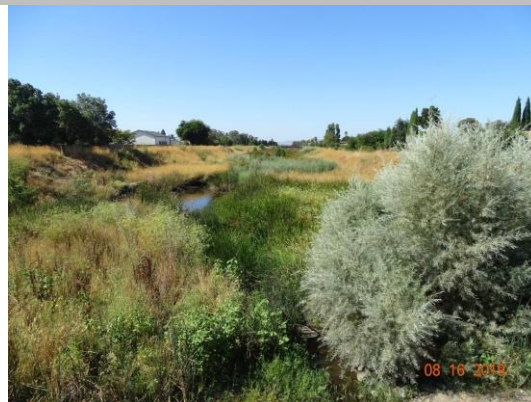
Photo 1 of 1 : CH_2019_NA0035_14_26_20190819_00037.jpg

View of the channel looking downstream. Summer 2019.

Inspector Comments: Clear out grass and woody vegetation.

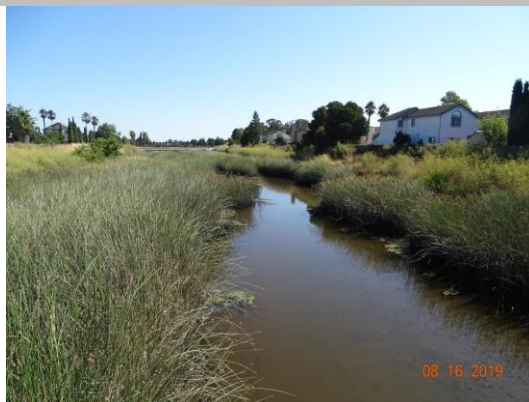
Photo 1 of 1 : CH_2019_NA0035_14_31_20190819_00036.jpg

Inspector Comments: Minimal, scattered obstructions or vegetation. The flow is not impeded.

View of the channel looking upstream. Summer 2019.

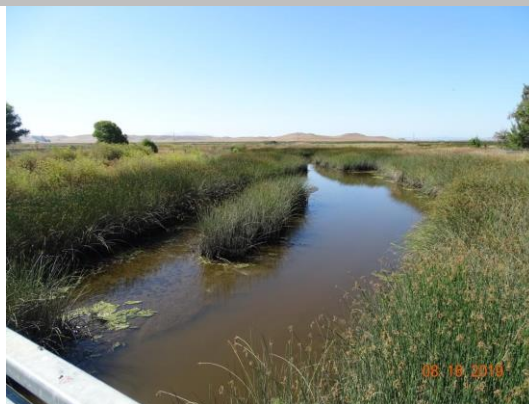
Photo 1 of 1 : CH_2019_NA0035_14_36_20190819_00035.jpg

Rating **	A	Issue No.	36	GPS Lat/Long
Issue Type +	Ma	Location *		38.241537 °
Category	Rivers, Channels & Designated Flood			-122.012077 °
Item	Vegetation & Obstructions			
DWR ID	DWR_NA0035_14_c_2012_36			
Action/Comments				
Inspector Comments: Minimal, scattered obstructions or vegetation. The flow is not impeded.

View of the channel looking downstream. Summer 2019.

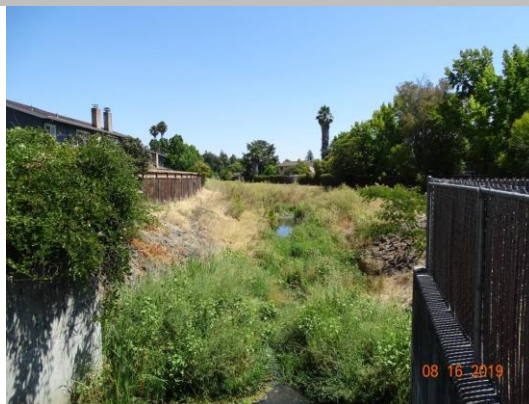
Photo 1 of 1 : CH_2019_NA0035_16_6_20190819_00037.jpg

Rating **	A	Issue No.	6	GPS Lat/Long
Issue Type +	Ma	Location *		38.280585 °
Category	Rivers, Channels & Designated Flood			-122.034039 °
Item	Vegetation & Obstructions			
DWR ID	DWR_NA0035_16_c_2012_6			
Action/Comments				
Inspector Comments: Minimal, scattered obstructions or vegetation. The flow is not impeded.

View of the channel looking downstream. Summer 2019.

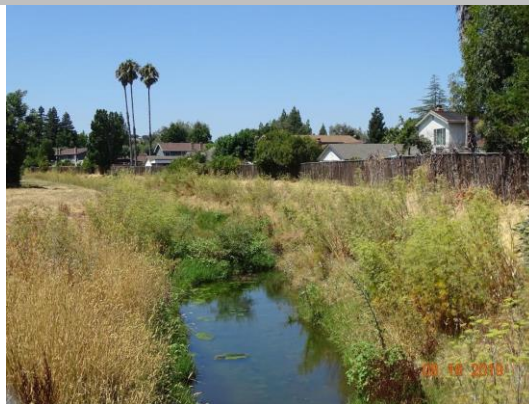
Photo 1 of 1 : CH_2019_NA0035_16_11_20190819_00036.jpg

Inspector Comments: Minimal, scattered obstructions or vegetation. The flow is not impeded. Cactus should be removed.

View of the channel looking upstream. Summer 2019.

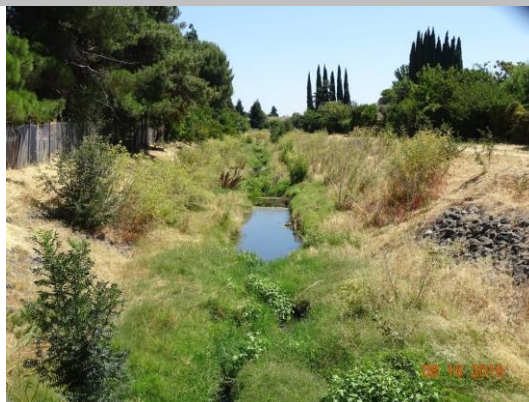
Photo 1 of 1 : CH_2019_NA0035_16_16_20190819_00035.jpg

Check Point / View				
Camrose Ave / Down				
Rating **	A	Issue No.	16	GPS Lat/Long
Issue Type +	Ma	Location *		38.281544 °
Category	Rivers, Channels & Designated Flood			-122.030543 °
Item	Vegetation & Obstructions			
DWR ID	DWR_NA0035_16_c_2012_16			
Action/Comments				
Inspector Comments: Minimal, scattered obstructions or vegetation. The flow is not impeded.

View of the channel looking downstream. Summer 2019.

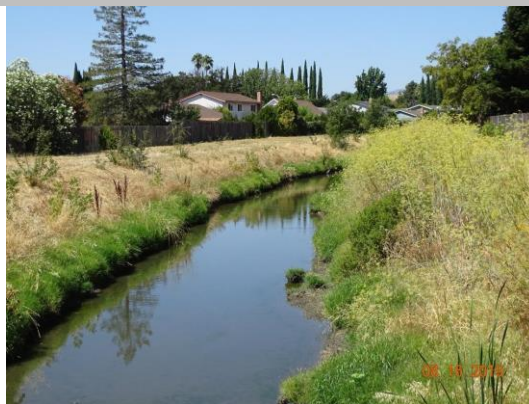
Photo 1 of 1 : CH_2019_NA0035_16_21_20190819_00034.jpg

Rating **	A	Issue No.	21	GPS Lat/Long
Issue Type +	Ma	Location *		38.280990 °
Category	Rivers, Channels & Designated Flood			-122.024750 °
Item	Vegetation & Obstructions			
DWR ID	DWR_NA0035_16_c_2012_21			
Action/Comments				
Inspector Comments: Minimal, scattered obstructions or vegetation. The flow is not impeded.

View of the channel looking upstream. Summer 2019.

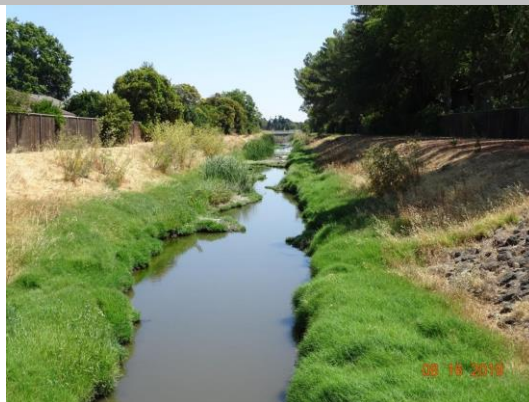
Photo 1 of 1 : CH_2019_NA0035_16_26_20190819_00033.jpg

Check Point / View				
Dover Ave / Down				
Rating **	A	Issue No.	26	GPS Lat/Long
Issue Type +	Ma	Location *		38.280946 °
Category	Rivers, Channels & Designated Flood			-122.025034 °
Item	Vegetation & Obstructions			
DWR ID	DWR_NA0035_16_c_2012_26			
Action/Comments				
Inspector Comments: Minimal, scattered obstructions or vegetation. The flow is not impeded.

View of the channel looking downstream. Summer 2019.

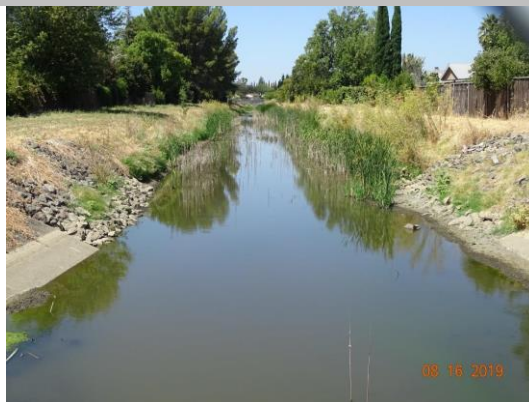
Photo 1 of 1 : CH_2019_NA0035_16_31_20190819_00032.jpg

Check Point / View				
Gulf Dr / Up				
Rating **	A	Issue No.	31	GPS Lat/Long
Issue Type +	Ma	Location *		38.281002 °
Category	Rivers, Channels & Designated Flood			-122.020570 °
Item	Vegetation & Obstructions			
DWR ID	DWR_NA0035_16_c_2012_31			
Action/Comments				
Inspector Comments: Minimal, scattered obstructions or vegetation. The flow is not impeded.

View of the channel looking upstream. Summer 2019.

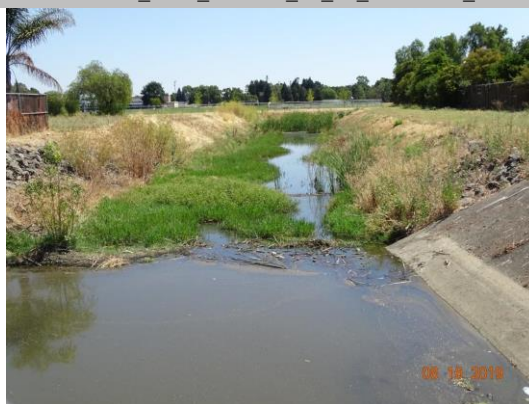
Photo 1 of 1 : CH_2019_NA0035_16_36_20190819_00031.jpg

Check Point / View				
Gulf Dr / Down				
Rating **	A	Issue No.	36	GPS Lat/Long
Issue Type +	Ma	Location *		38.280937 °
Category	Rivers, Channels & Designated Flood			-122.020629 °
Item	Vegetation & Obstructions			
DWR ID	DWR_NA0035_16_c_2012_36			
Action/Comments				
Inspector Comments: Minimal, scattered obstructions or vegetation. The flow is not impeded.

View of the channel looking downstream. Summer 2019.

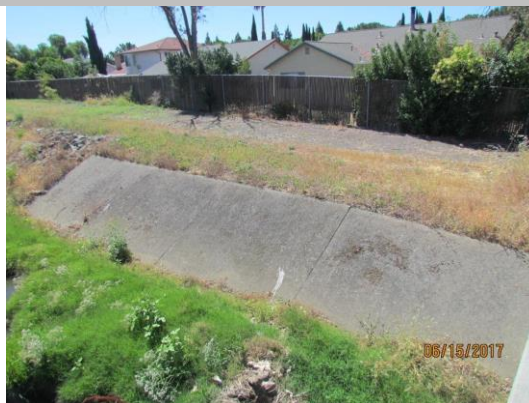
Photo 1 of 1 : CH_2019_NA0035_16_42_20190801_00030.jpg

Rating **	A	Issue No.	42	GPS Lat/Long
Issue Type +	Ma	Location *		38.281002 °
Category	Rivers, Channels & Designated Flood			-122.020570 °
Item	Concrete Surfaces			
DWR ID	DWR_NA0035_16_c_2017_42			
Action/Comments				
Inspector Comments: Concrete surface appears to be in good condition with no visible deficiencies.

View of concrete surface on right bank, looking downstream. Summer 2017.
